Case Study: Application of Motionics Wireless Dial Indicators (BlueDial) in Wind Turbine Gearbox Maintenance

Hardware: [BlueDial Wireless Dial Indicator](#) – BD10-783

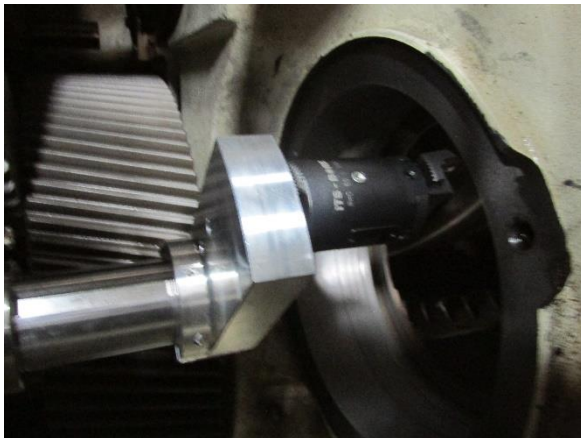
Fig. 1 Shop application of gearbox repair method

To prevent this condition from destroying the gearbox, the company in this case has developed a field repair that corrects the problem. This process involves boring the hole oversize, installing a sleeve, and then putting an anti-rotation device in the outer race of the bearing. This prevents the outer race from spinning.

To conduct this repair, the gearbox must be mostly disassembled. Then, a boring bar is used to cut out the damaged material and then install a sleeve made from similar material to the gearbox case. This ensures that the thermal expansion range of the installed sleeve is close to the same as the housing.

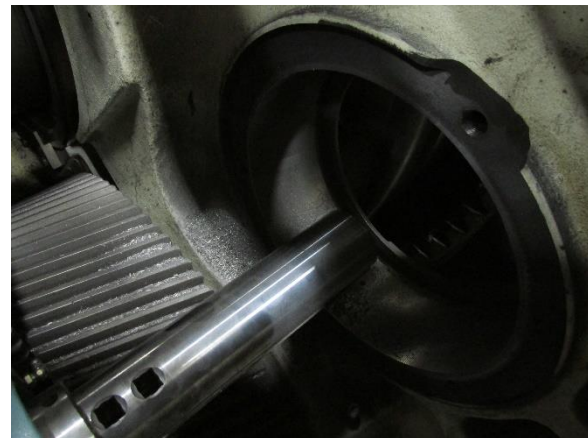
Fig. 2 Shop application of gearbox repair method

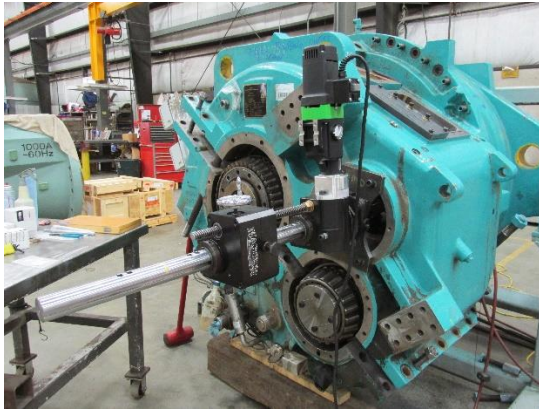
Fig. 3 Shop application of gearbox repair method

The BlueDial wireless dial indicator is critical to the success of this process. This is due to the fact that the bearing bore that requires repair is located inside the gearbox, so no conventional dial indicator could be seen by the machinist in order to measure and then adjust the angle of the boring bar to verify perfect alignment with the hole.

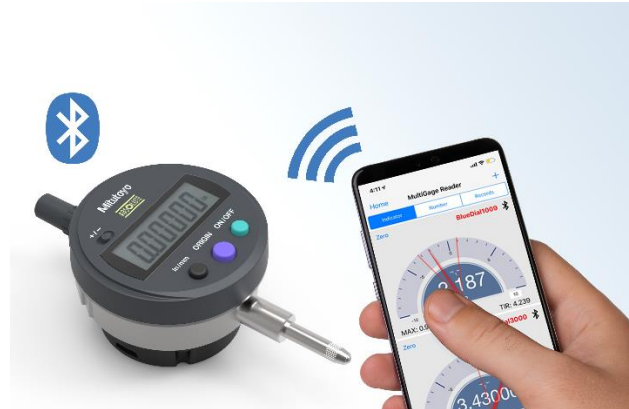
Fig. 4 BlueDial transmits readings wirelessly

BlueDial will transmit readings via Bluetooth to a smart device using Motionics' MultiGage Reader application, so the user can view and record readings without having to look at the indicator face itself. The remote reading of the indicator allows the machinist to mount the indicator on the end of the boring bar and sweep the bore to set the alignment, and then again to verify that the final bore dimension is correct to fit the OD of the bearing.
