Case Study

Fan/Blower Vibration Analysis & Rotor Balancing

With Motionics iPad 2CH Vibration Analysis & Rotor Balancing Kit

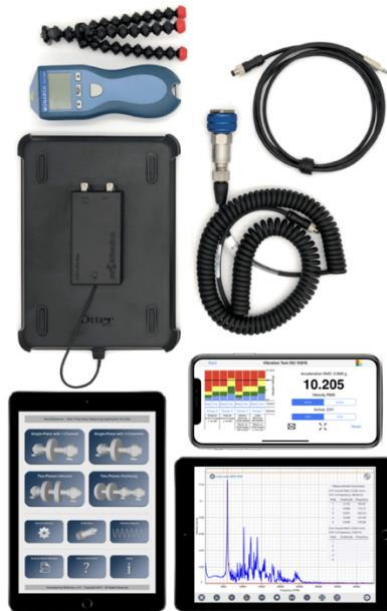
Figure 1 Motionics Wired 2CH Vibration Analysis & Rotor Balancing Kit

VTK is a fan and blower manufacturing and maintenance company in the Netherlands. Operators at VTK frequently check fan and blower vibration conditions and perform balancing work if an imbalance is detected. Motionics wired 2CH vibration analysis and rotor balancing kit integrates a DAQ system on an iPad case and allows operators to complete vibration checks and rotor balancing on an iPad.

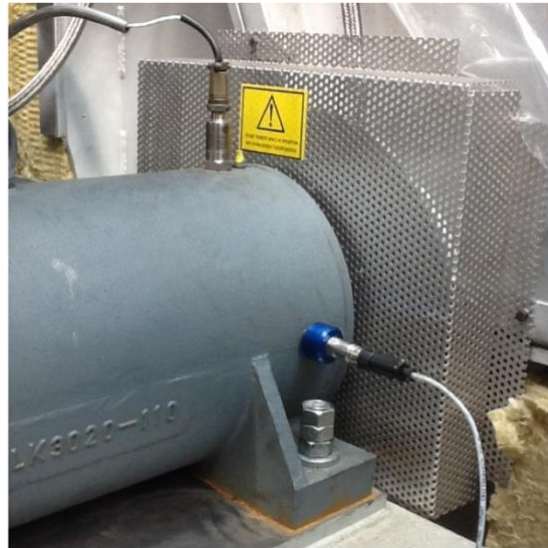
Figure 2 Vibration testing on a blower

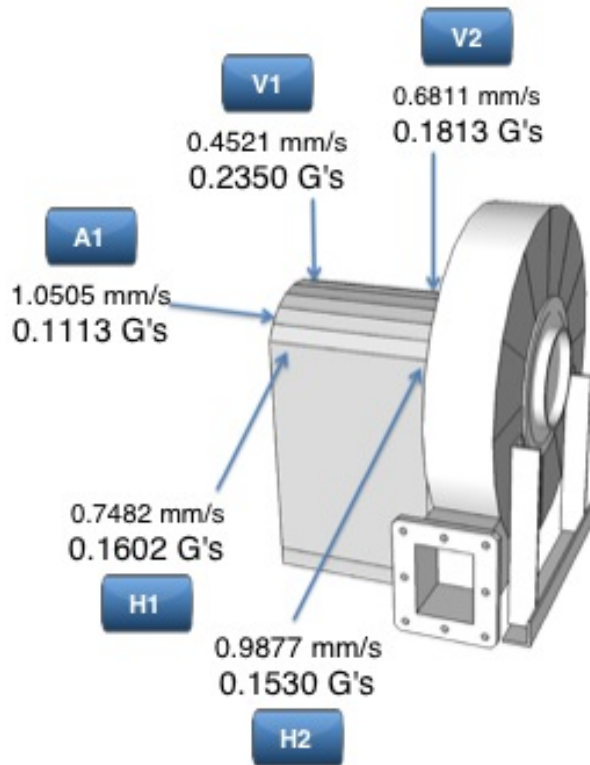
Report 1 is a vibration test report generated from iVibraMeter. An operator tested vibration at 5 points on the blower and a picture with acceleration and velocity readings at these 5 test points was shown in the report. Other test information, such as date/time, staff, location, machine, notes, signature, map, and machine images were also included in the report.

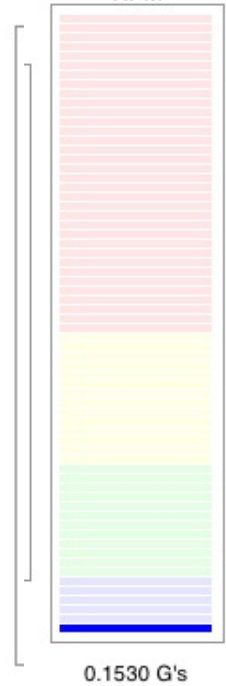
Motionics Bearing
Vibration Severity for
Shafts 600-1800
RPM

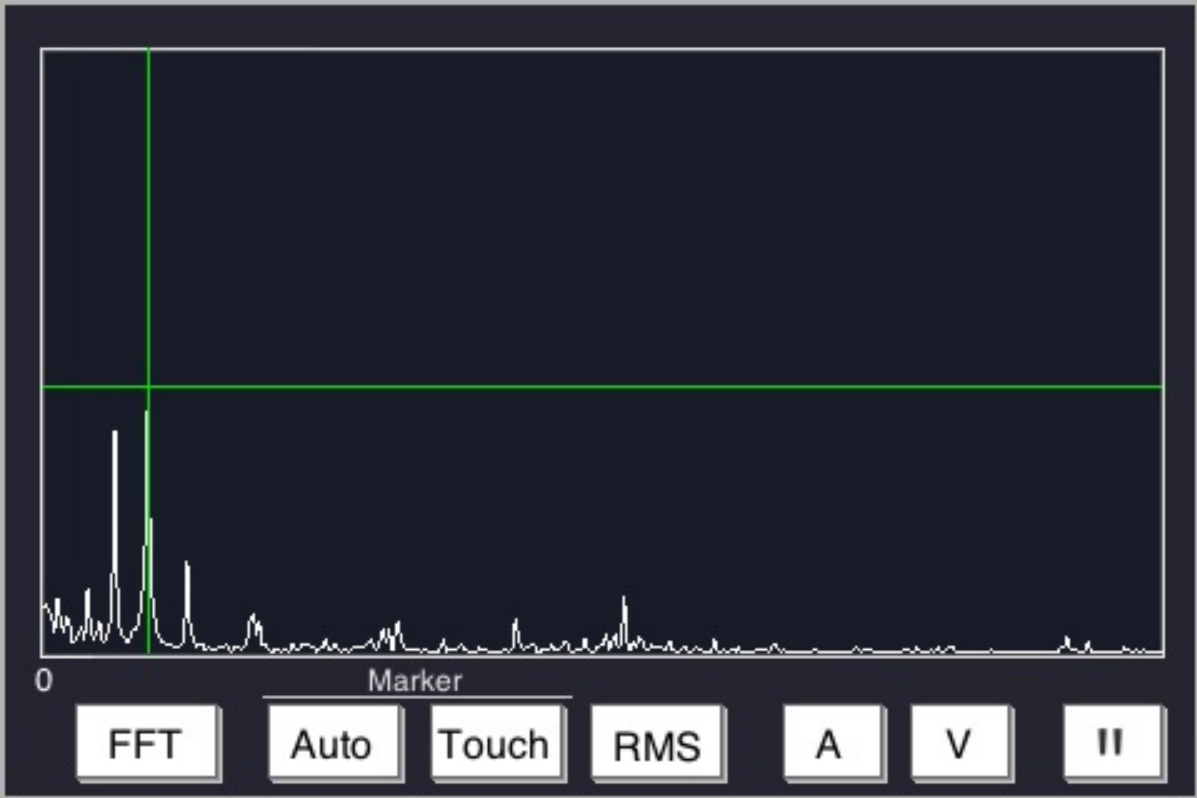
Report 2 is a rotor balancing report generated from iRotorBalancer. An operator conducted single-plane 2-channel balancing on the blower and reduced vibration magnitude from 0.0659 to 0.0097 ips. The test report includes general test information, balancing parameters, notes, signature, spectrum, machine images, and map.

Magnitude	Angle
Original Vibration:	0.0659	51°
Trial Weight (gr):	8.0000	231°
Trial Weight Radius (mm):	150.0000	
Vibration w/Trial Weight:	0.0482	56°
Correction Weight (gr):	29.0167	242°
Correction Weight Radius (mm):	150.0000	
Final Vibration:	0.0097	135°
