# ShakerWatch Vibration Test Report

## Orbit Test

Operator:	Mike Steward	Date:	12/20/2022 05:54:40
Customer:	Nature Mine Texas	Media Type – Top:	Rock 736
Machine Size:	6x20 KPI	Media Type – Middle:	Rock 736
Machine S/N:	HDBUD6547	Media Type- Bottom:	Rock 736
Industry:	Coal Mine	Spring Height – Discharge Right (in):	0.0
Hand of Drive:	TBD	Spring Height – Discharge Left (in):	8.75
Expected RPM:	825	Spring Height – Feed Right (in):	8.62
Expected Stroke (in):	0.5	Spring Height – Feed Left (in):	8.75

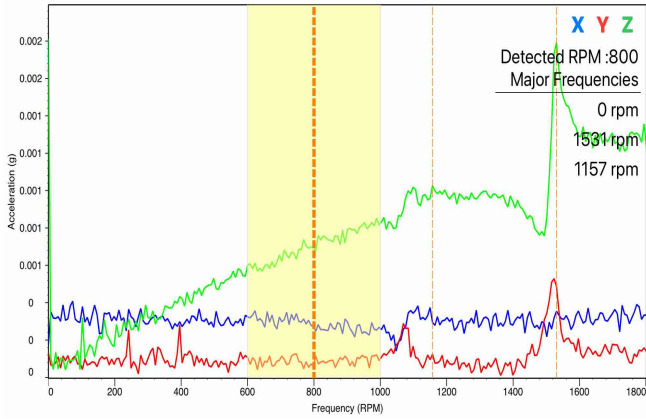
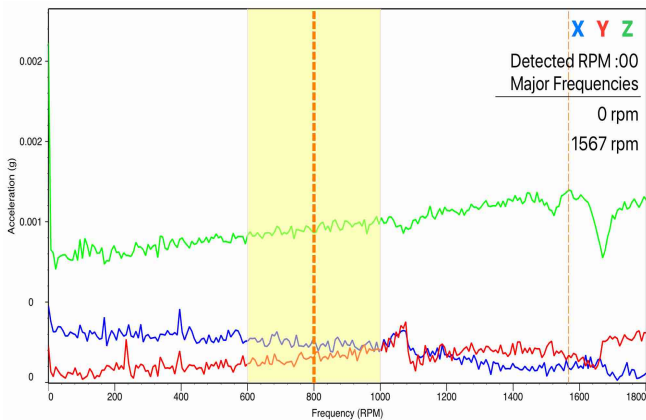
Running RPM: 800 RPM  
 Safe Band Setting for RPM : 200 RPM

Bump Test 5

Bump Test 6
